No. 9746

Circuit Court of Appeals

J. LESLIE MORRIS COMPANY, INC., a corporation,

(Plaintiff's Exhibits 1 to 32)

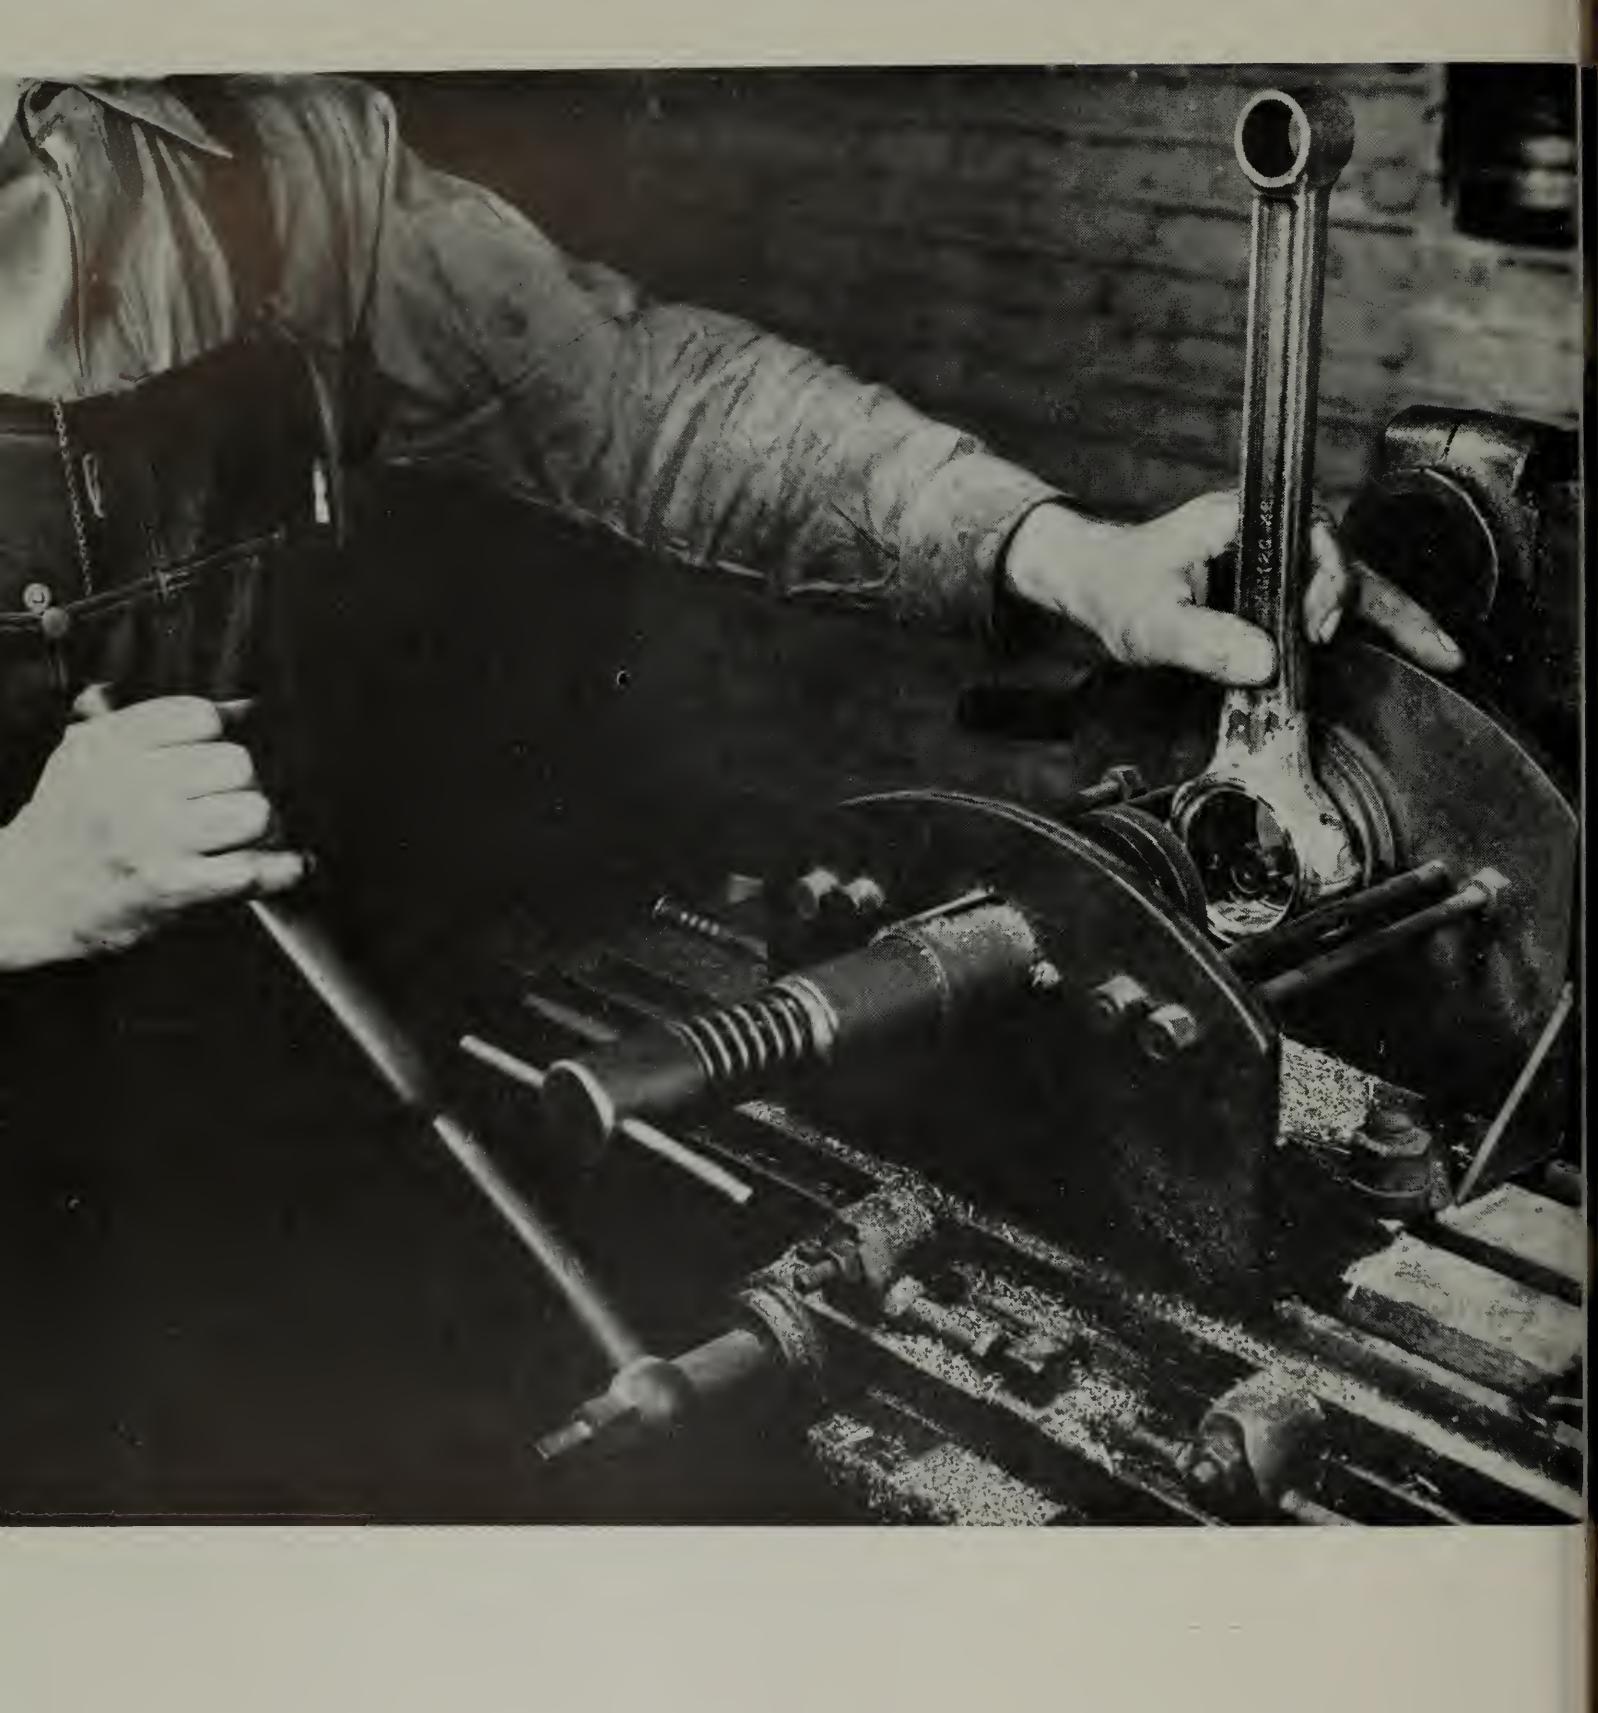
[Endorsed]: No. 433—M. Morris Co. v. U. S. A. Plf's Ex. No. 22. Filed 5/29/40. R. S. Zimmerman, Clerk. By B. B. Hansen, Deputy Clerk.

The lathe used in the above picture is identical with the one shown in Picture 21, however it is used for finishing babbitt bearings to special undersizes as ordered by the customer. About 20% of the connecting rods rebabbitted by the plaintiff are bored to special undersizes for the reason that the crankshafts of the automobiles in which they are to be placed have been reground in order to correct for the wear which has resulted from long operation.

All babbitt bearings except the twenty per cent which are finished to special undersize on the lathe shown in Picture 22 are now finished to size by a hydraulicly operated broaching machine as shown in the above picture. The broaching tool which is used for this operation is held in the workman's right hand. It is composed of a number of horizontal cutters each of which removes about .0005 as the tool is forced through the bearing by the hydraulic pressure.

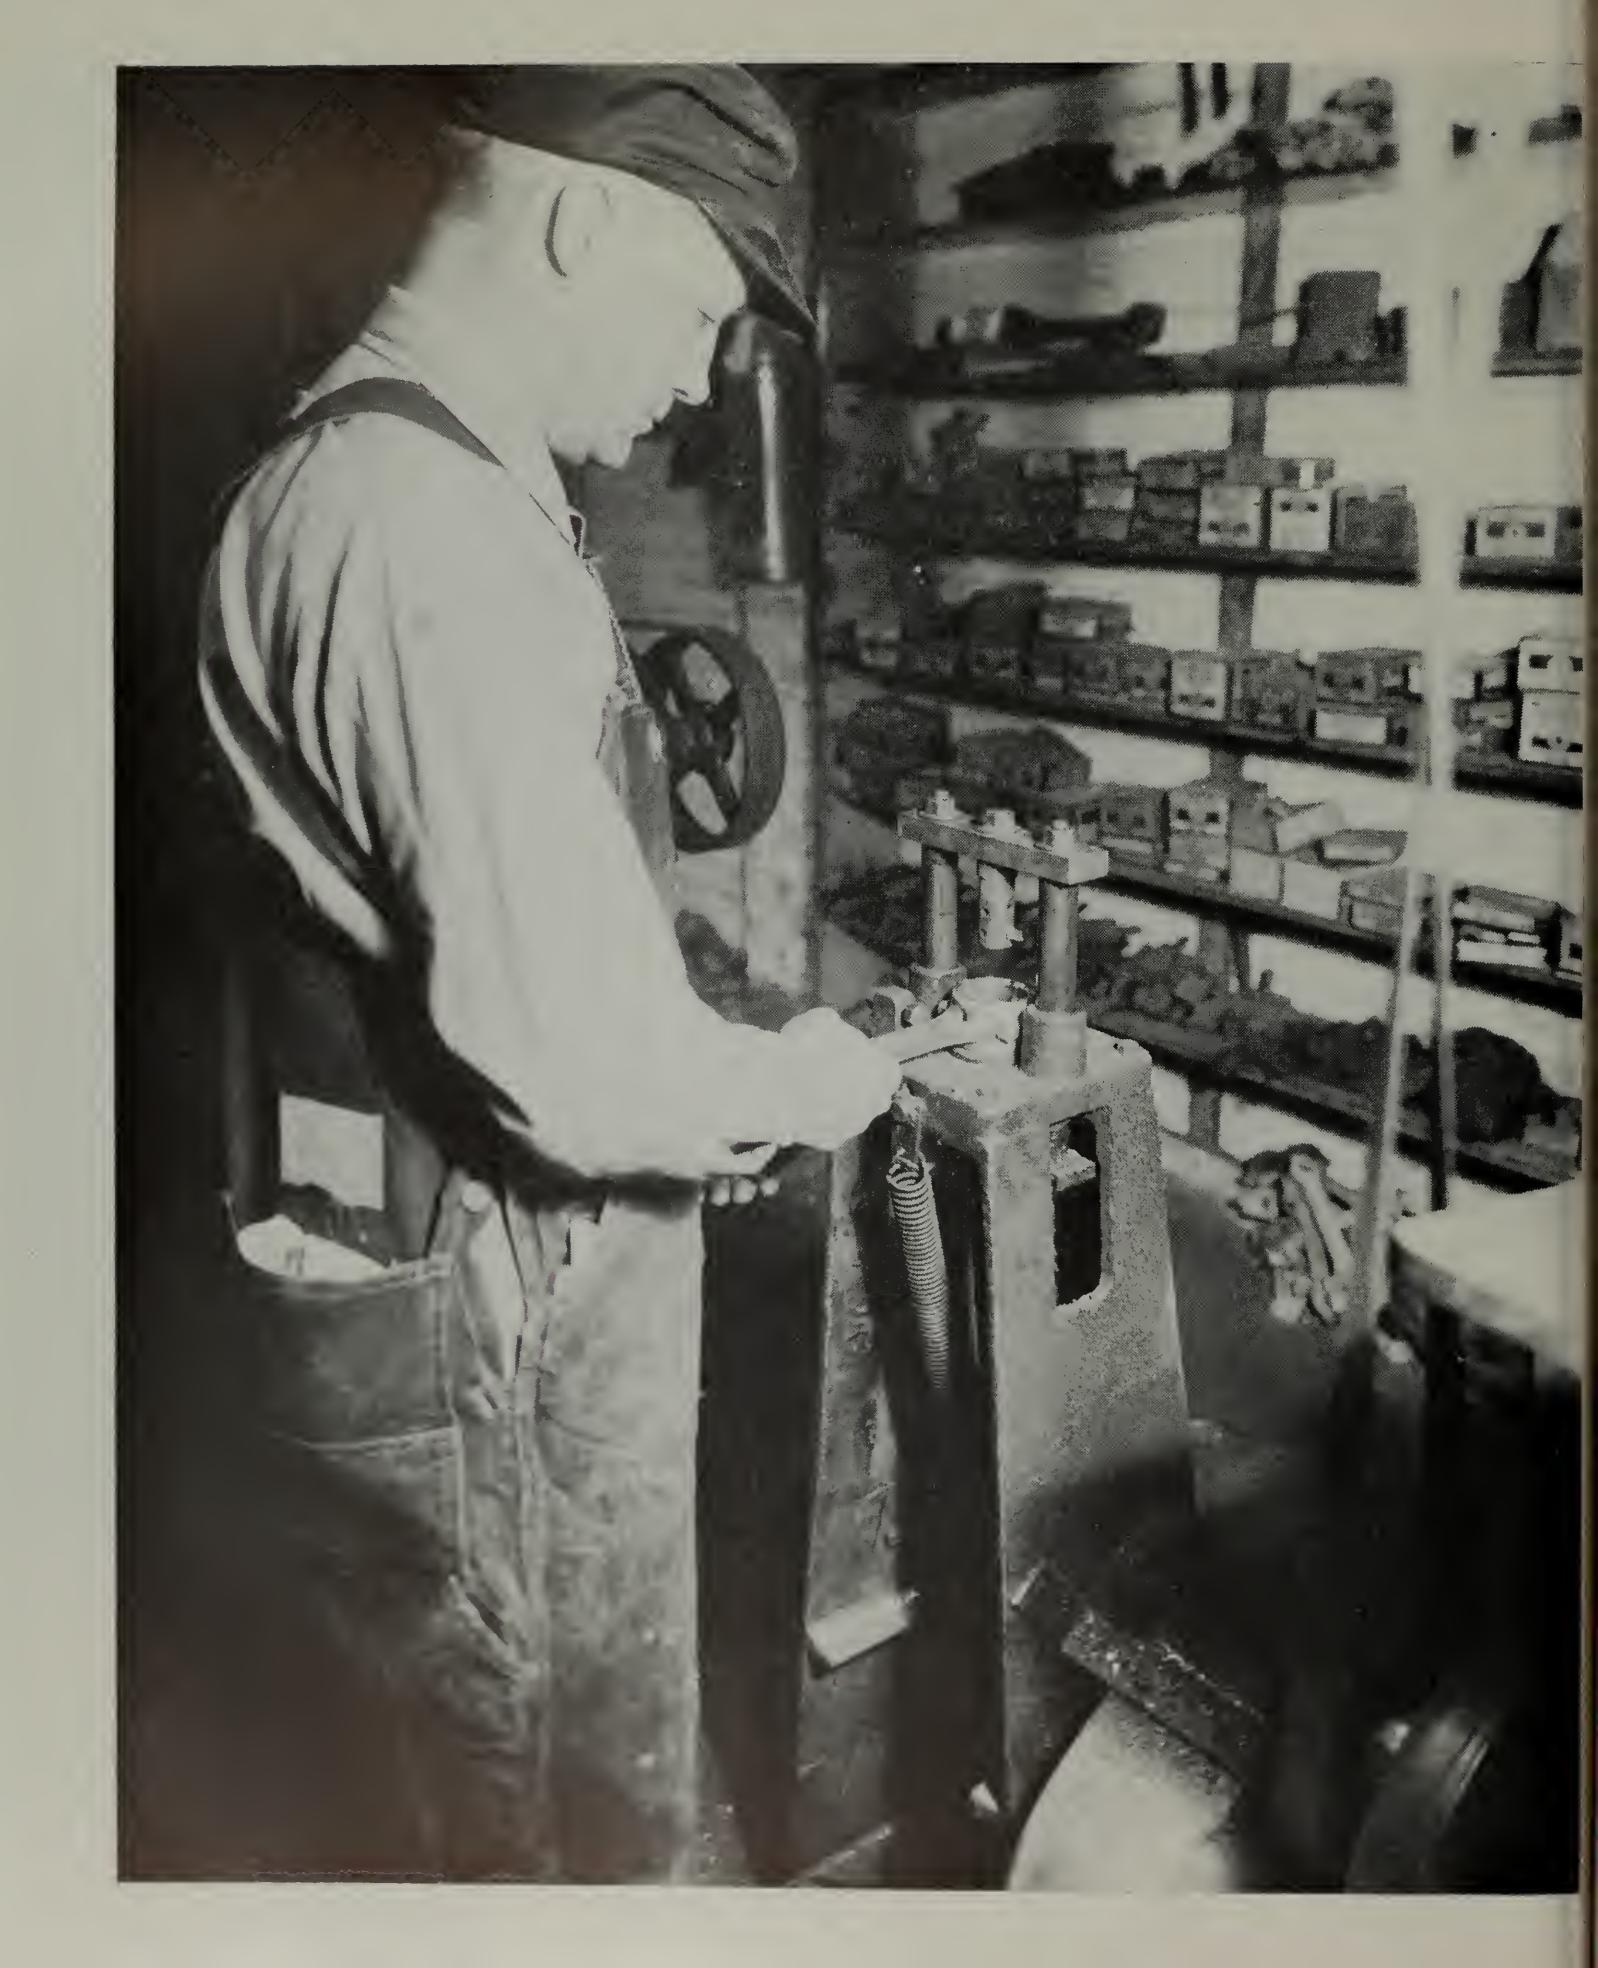
[Endorsed]: No. 433—M. Morris Co. v. U. S. A. Plf's Ex. No. 23. Filed 5/29/40. R. S. Zimmerman, Clerk. By B. B. Hansen, Deputy Clerk.

Approximately fifty per cent of the bearings have oil pockets which are cut by a hand milling machine as shown in the above picture.

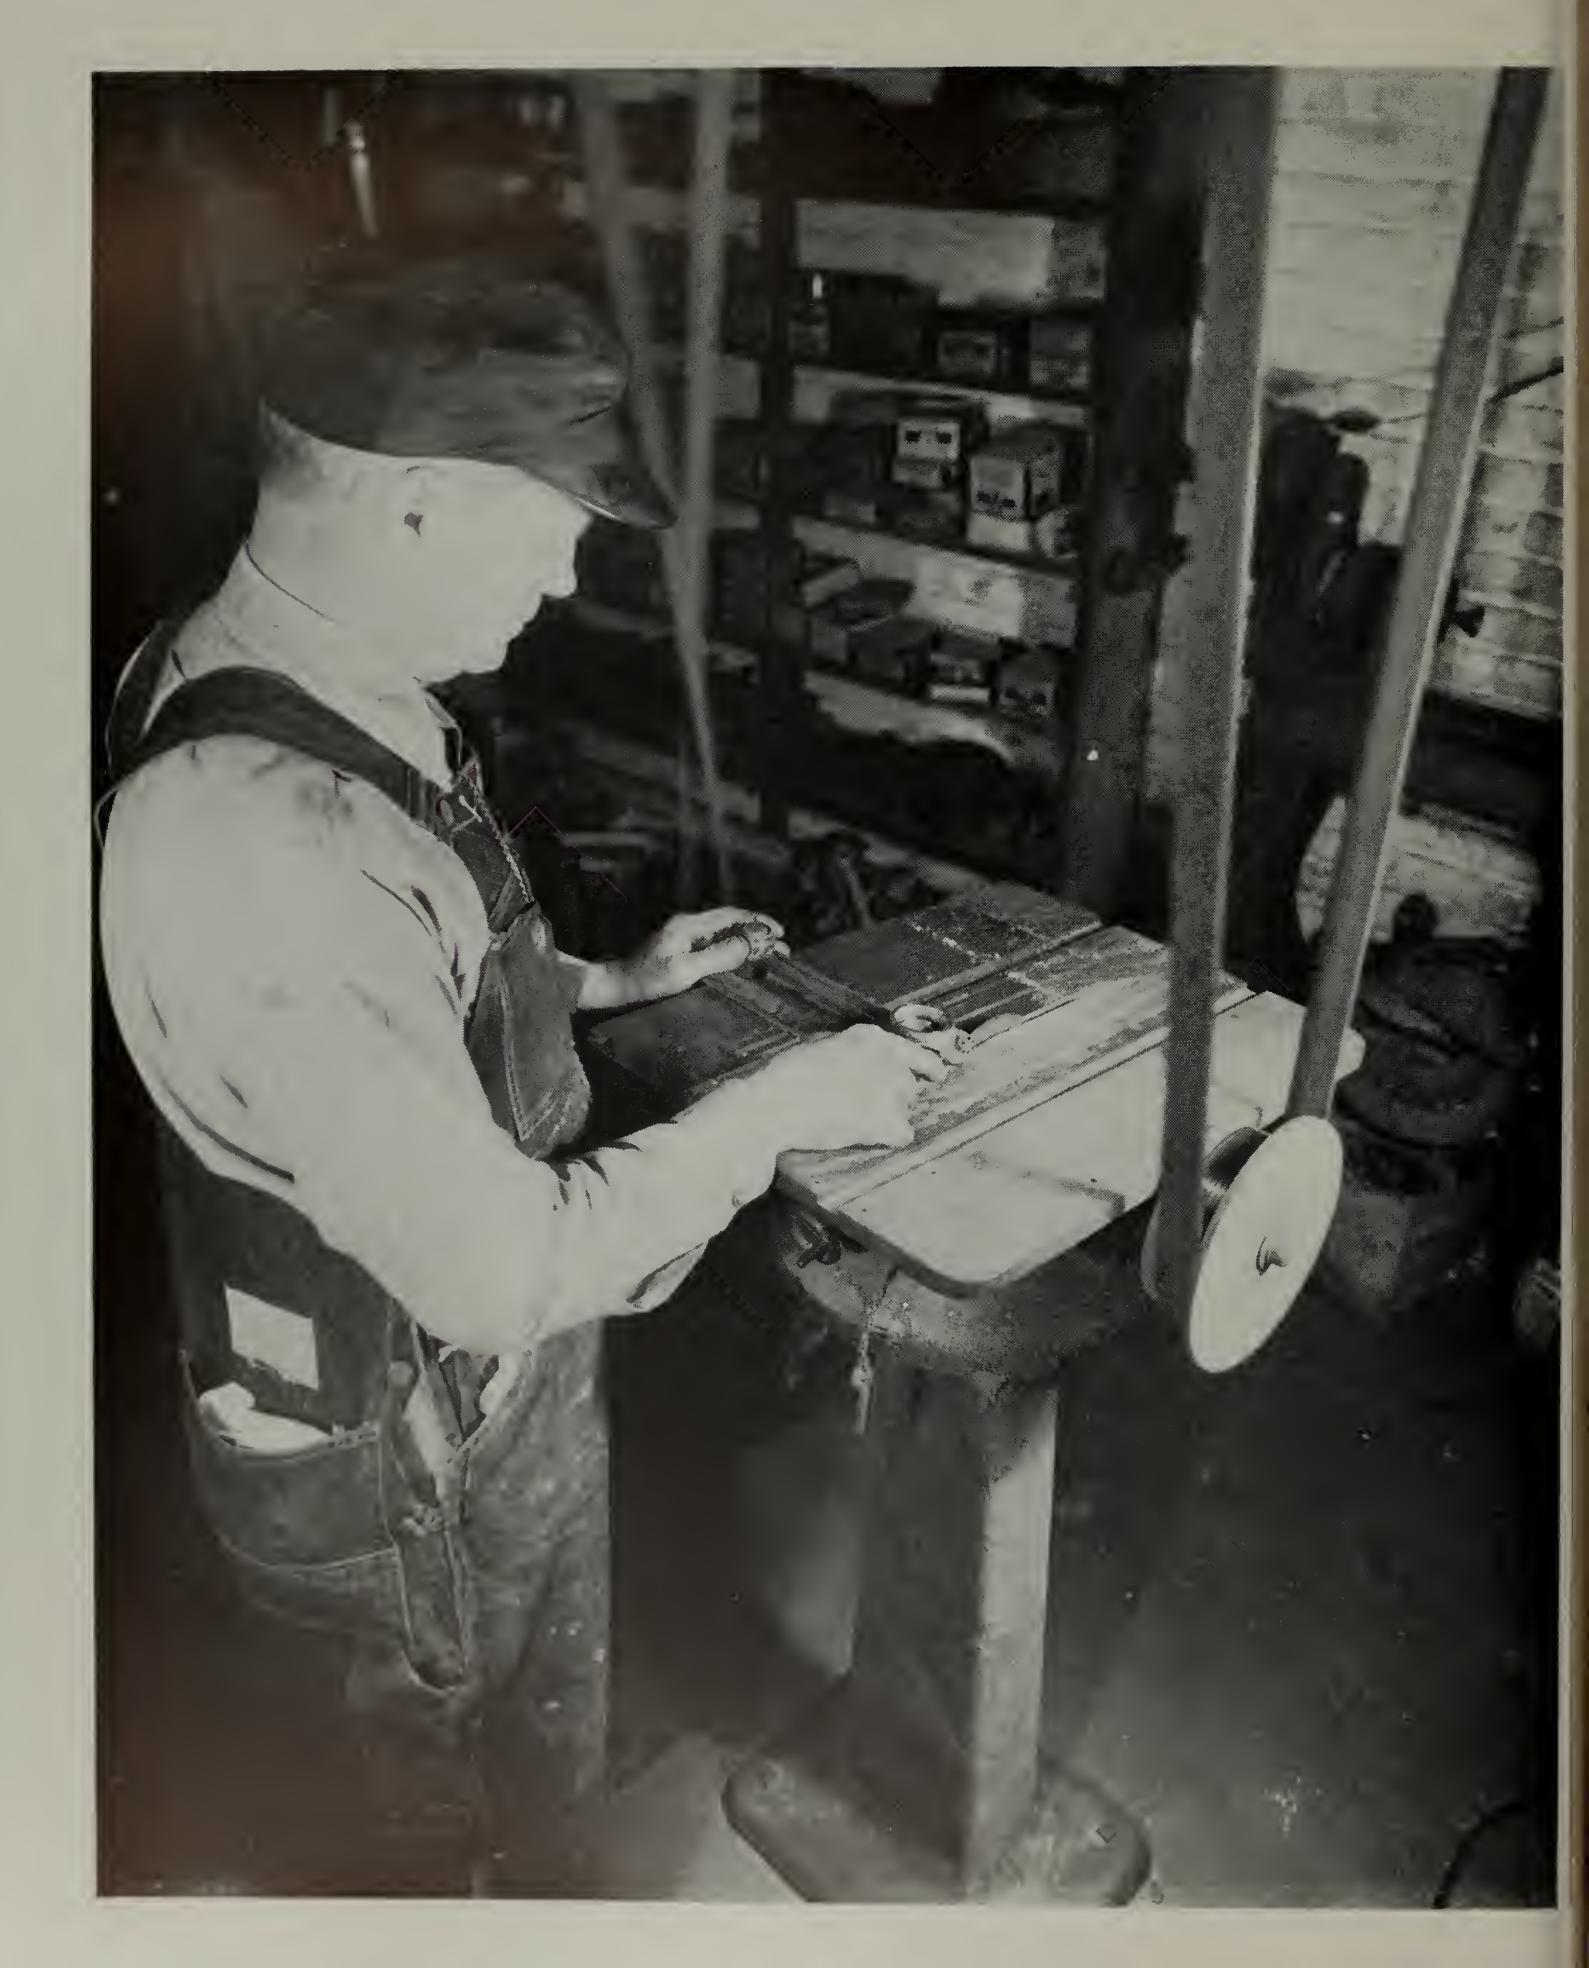
[Endorsed]: No. 433—M. Morris Co. v. U. S. A. Plf's Ex. No. 24. Filed 5/29/40. R. S. Zimmerman, Clerk. By B. B. Hansen, Deputy Clerk.

On Model A Ford connecting rods in which the babbitt was cast without the use of separator shims, it is necessary to cut the babbitt through the center of the bearing in order to free the cap from the shank. This operation also leaves an oil groove or relief which facilitates lubrication. This operation is performed by a slotting tool as shown in the above picture.

The Model A connecting rods are now on a saw table in which a rotating saw blade cuts the babbitt flange to complete the separating operation as shown in Picture 24. This also cuts the necessary oil relief groove through the flange.

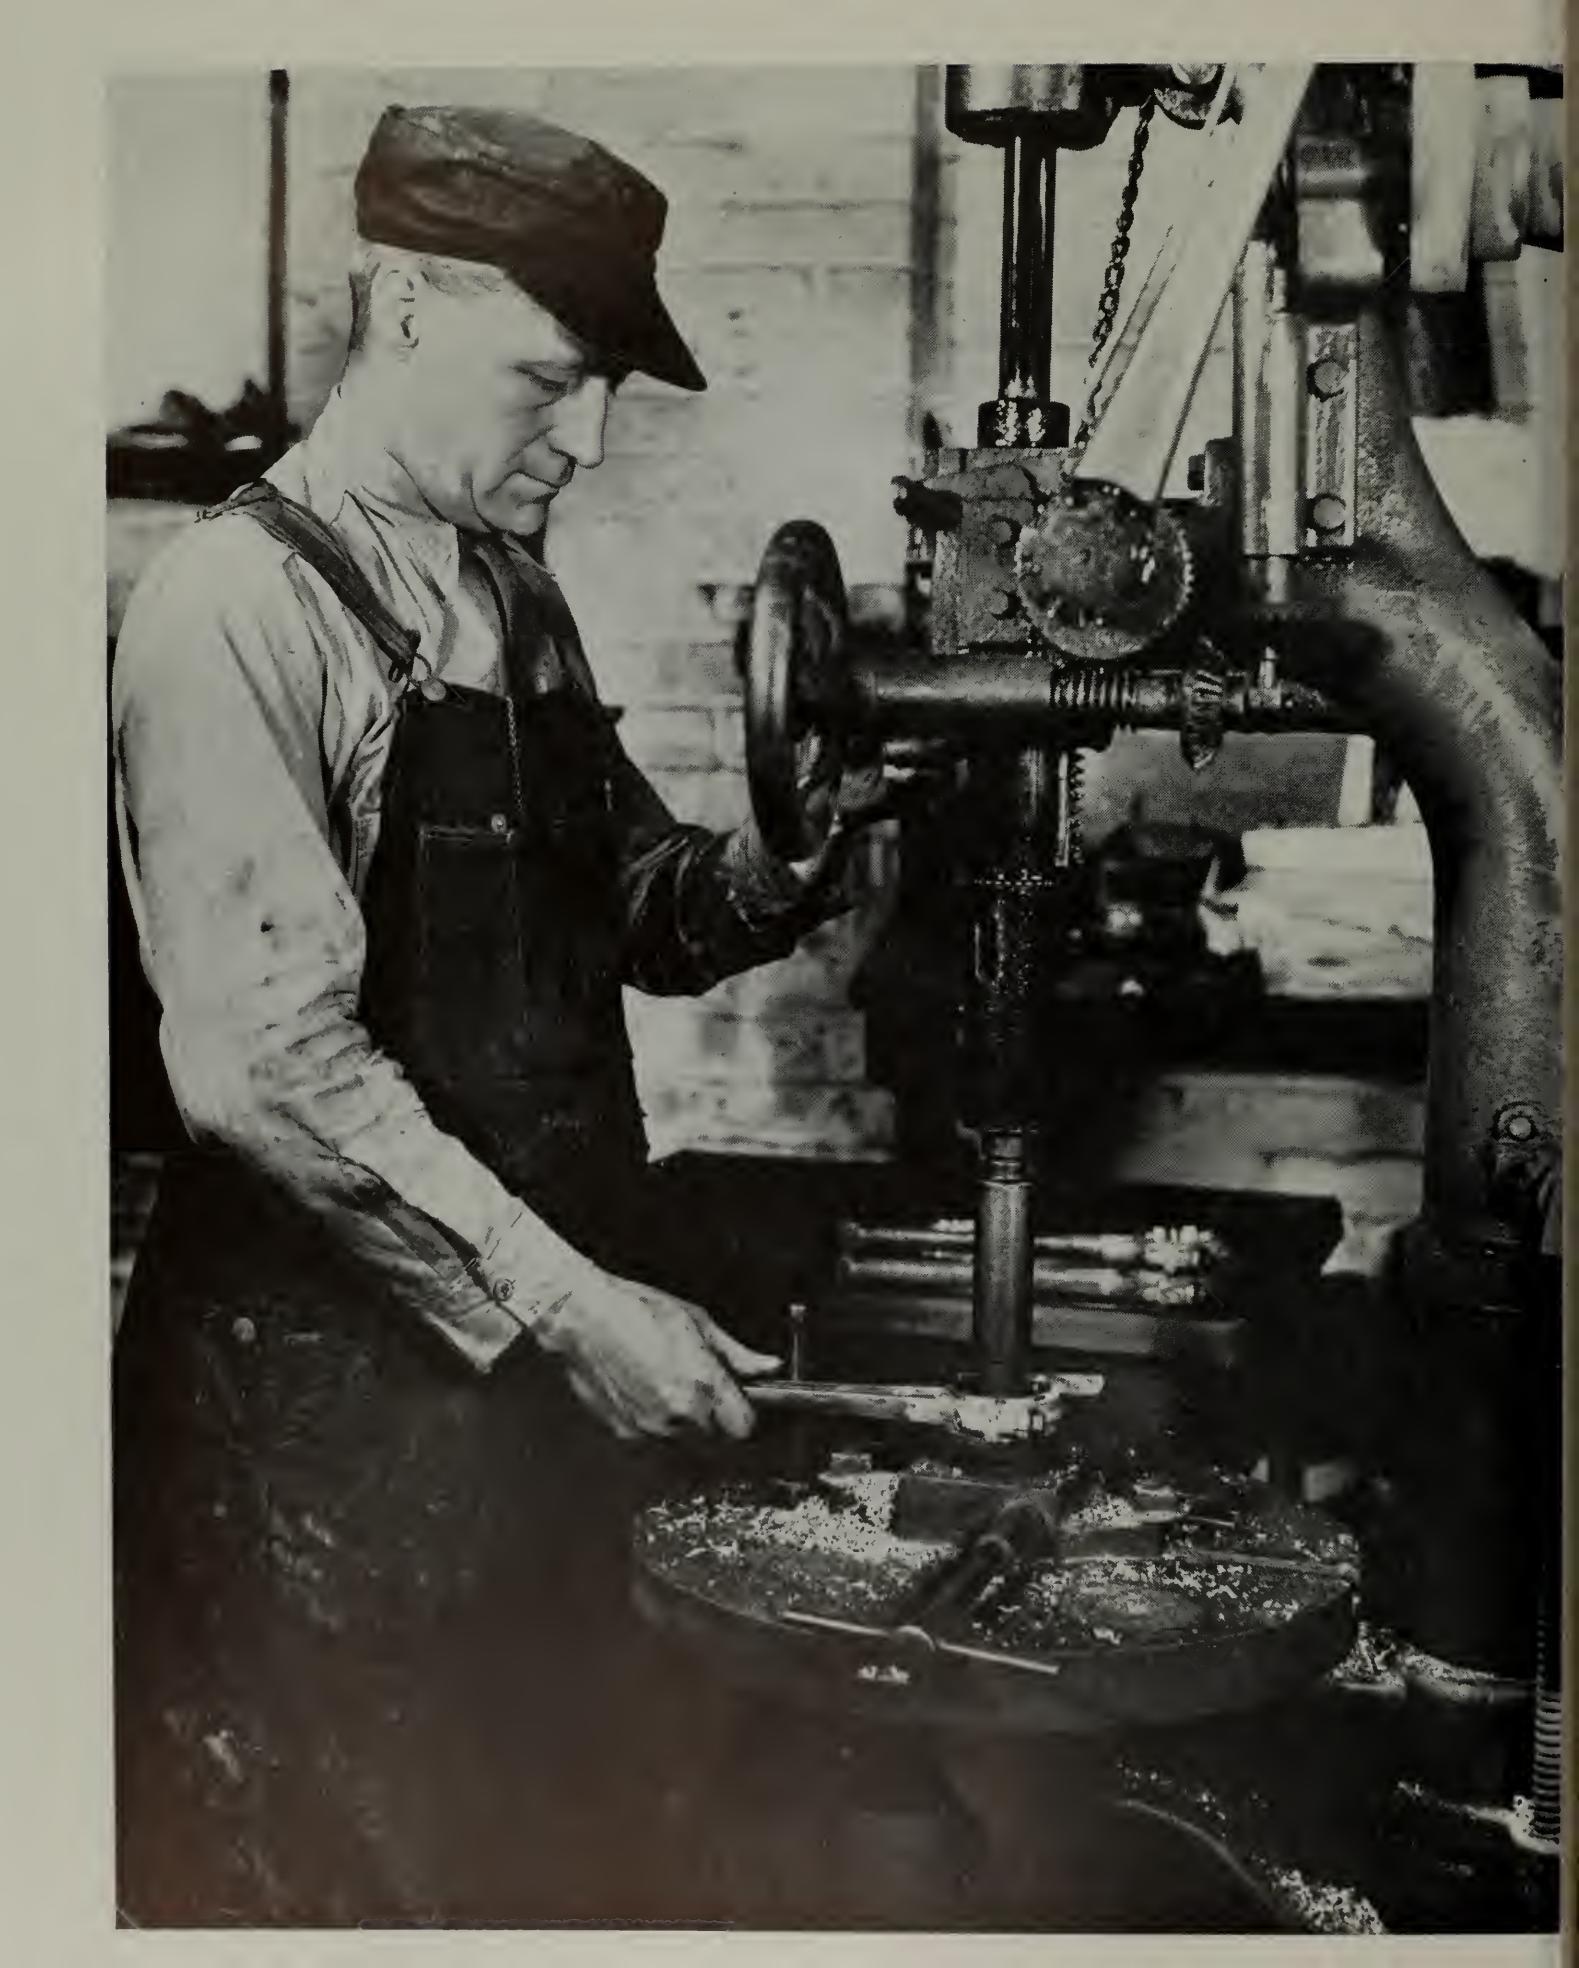
[Endorsed]: No. 433—M. Morris Co. v. U. S. A. Plf's Ex. No. 26. Filed 5/29/40. R. S. Zimmerman, Clerk. By B. B. Hansen, Deputy Clerk.

About one half of the connecting rods rebabbitted require new bushings in small end of the shank. These are installed by a hand operated arbor press, as shown above.

Model A Ford connecting rods are fitted with a very thin bushing which becomes somewhat damaged and burred when being pressed in by the arbor press shown in Picture 26. This is corrected by placing the connecting rods in a bench drill press in which a chamfering tool is used as shown in the above picture.

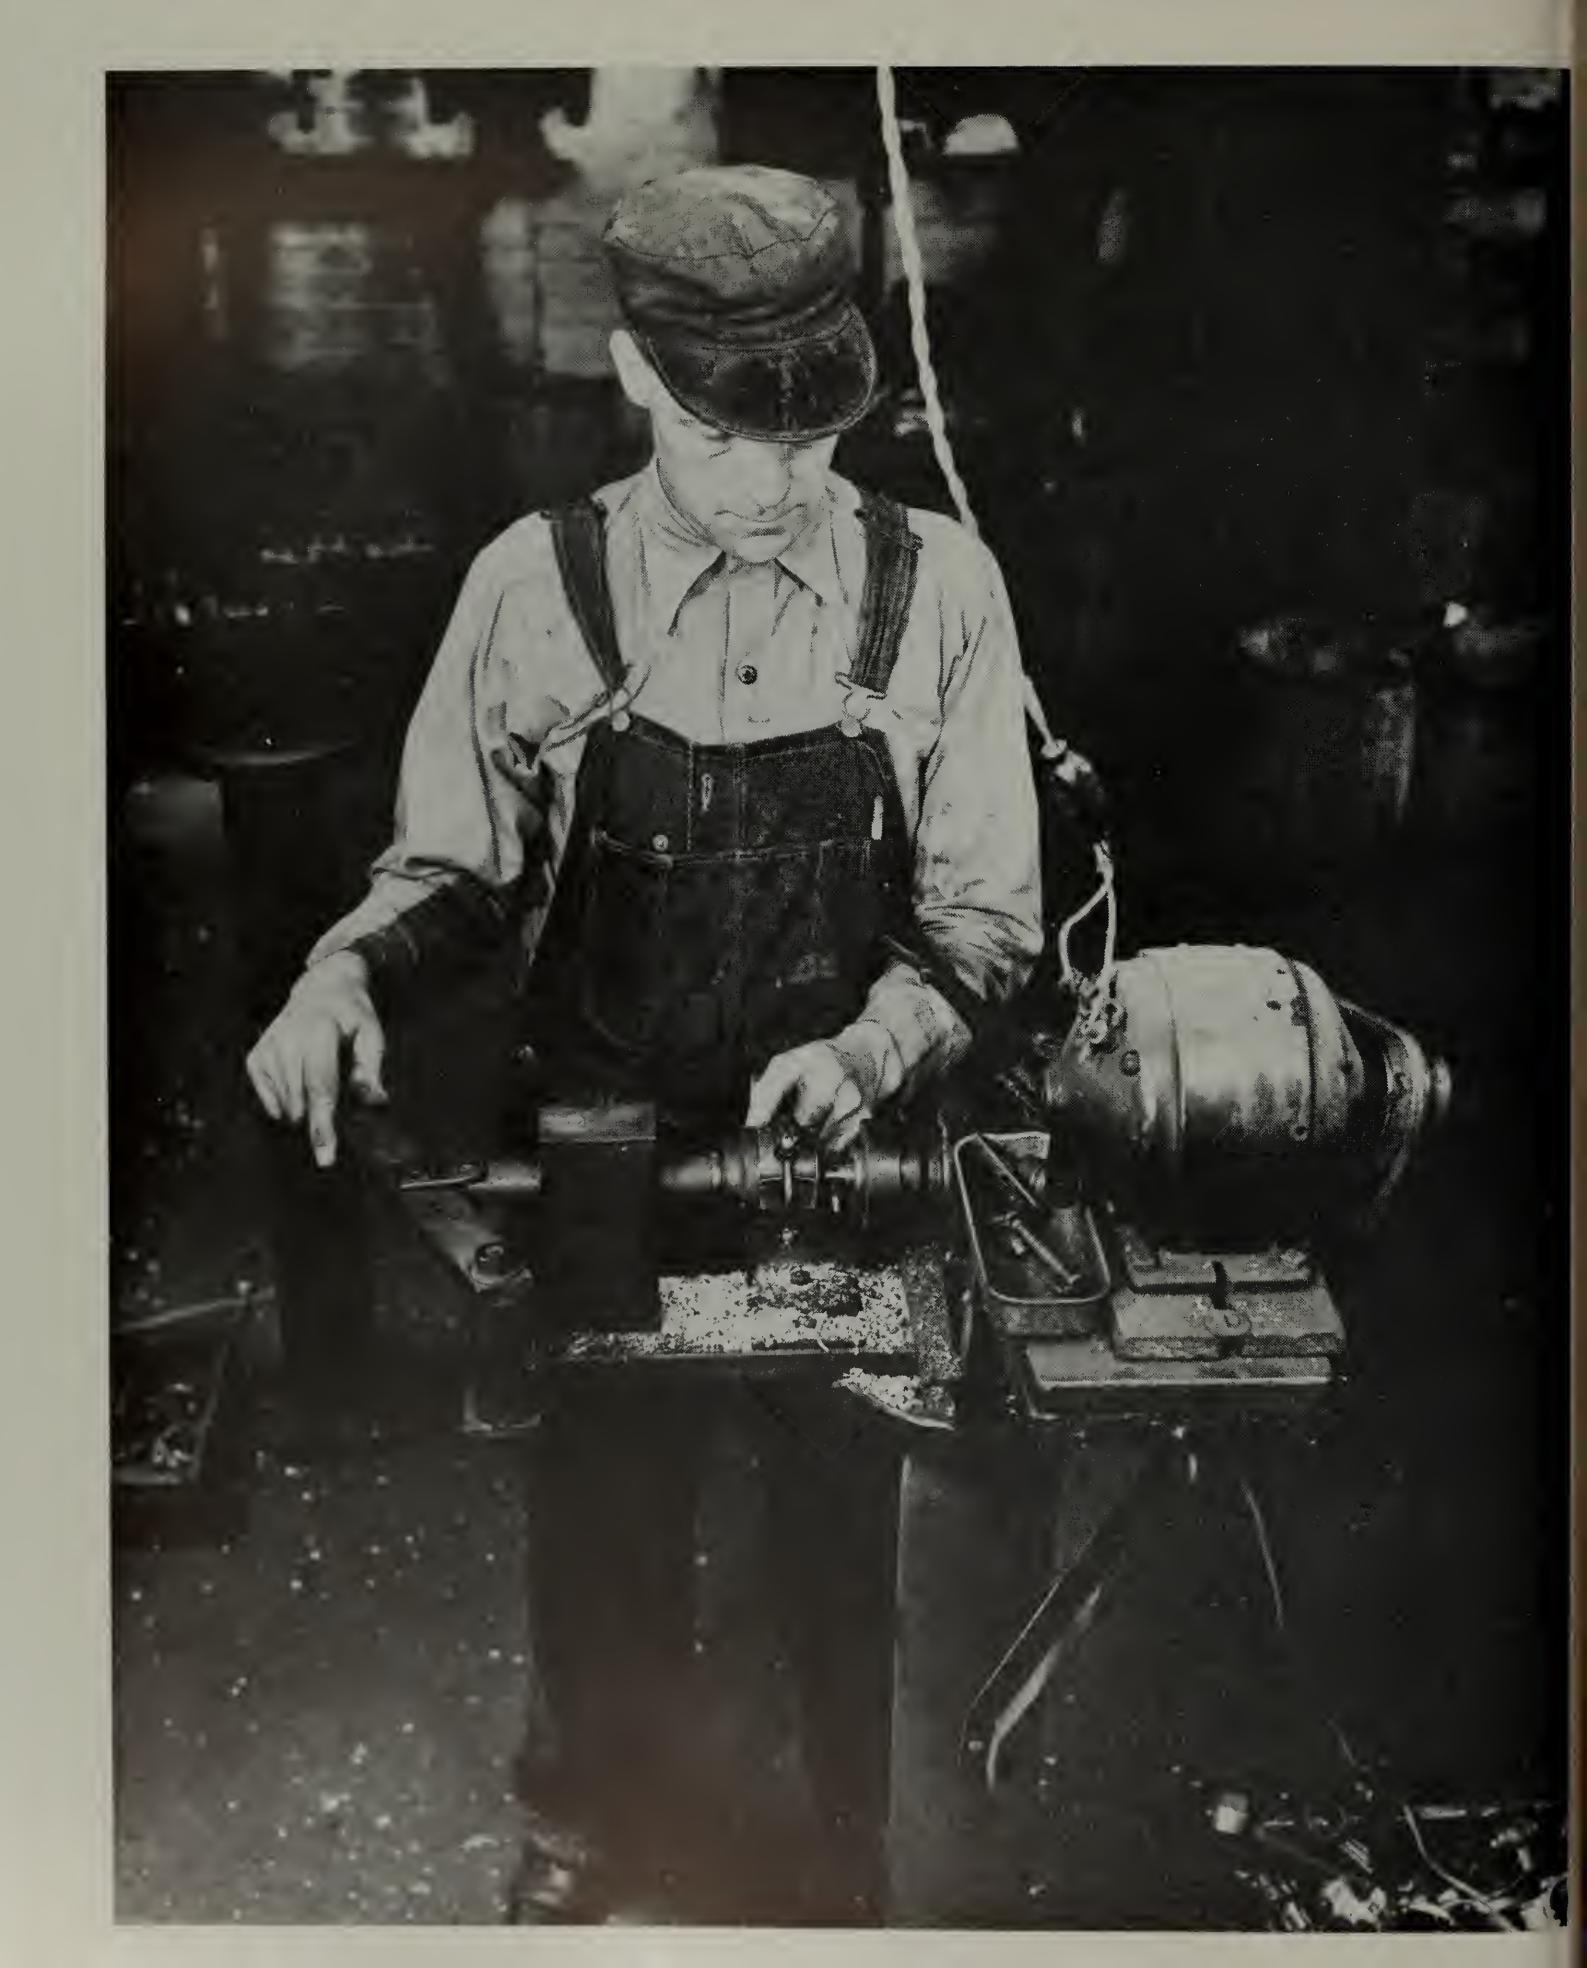
[Endorsed]: No. 433—M. Morris Co. v. U. S. A. Plf's Ex. No. 32. Filed 5/29/40. R. S. Zimmerman, Clerk. By B. B. Hansen, Deputy Clerk.

All Model A Ford and six-cylinder Chevrolet rebabbitted connecting rods require an oil groove on the face of the bearing which is cut in the shape of a figure 8 by hand operated oil groover as shown in the above picture.

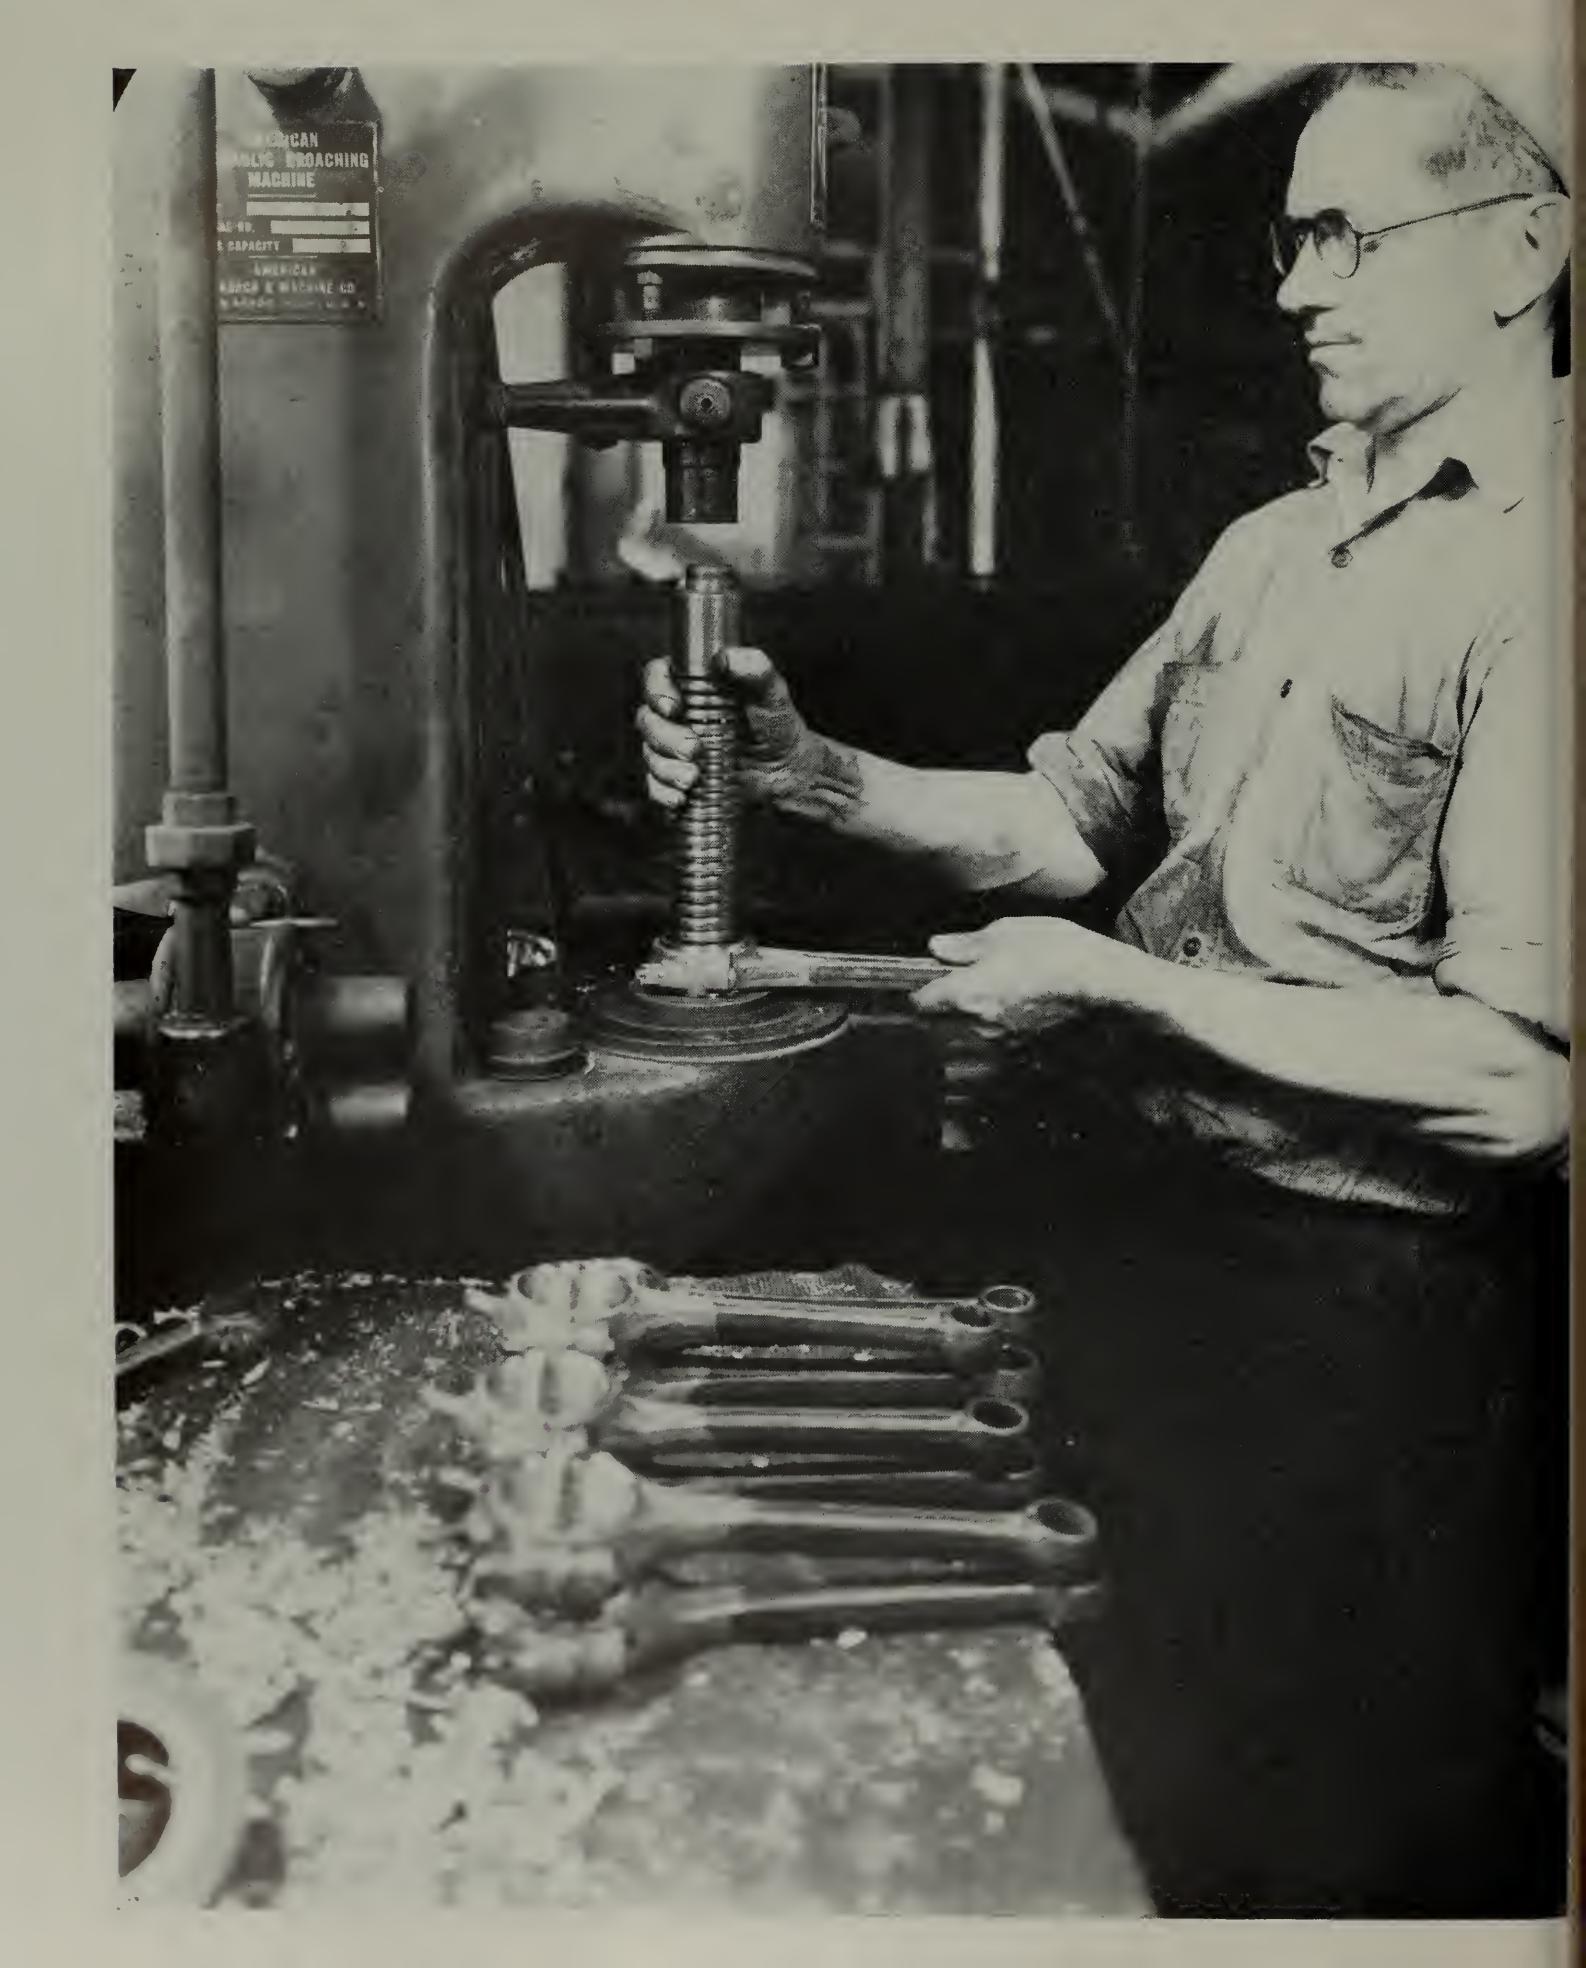
[Endorsed]: No. 433—M. Morris Co. v. U. S. A. Plf's Ex. No. 29. Filed 5/29/40. R. S. Zimmerman, Clerk. By B. B. Hansen, Deputy Clerk.

Certain Pontiac bearings require a continuous oil groove around the center, which is cut by the center oil groover shown in the above picture.
